SUBJECT: Audit of California Flats 150 Power Plant - Audit Number GA2021-13CF

**GO 167-B Audit Report
of the
*California Flats 150
Power Plant***

Audit Number GA2021-13CF

Audit Date: November 1 - 5, 2021

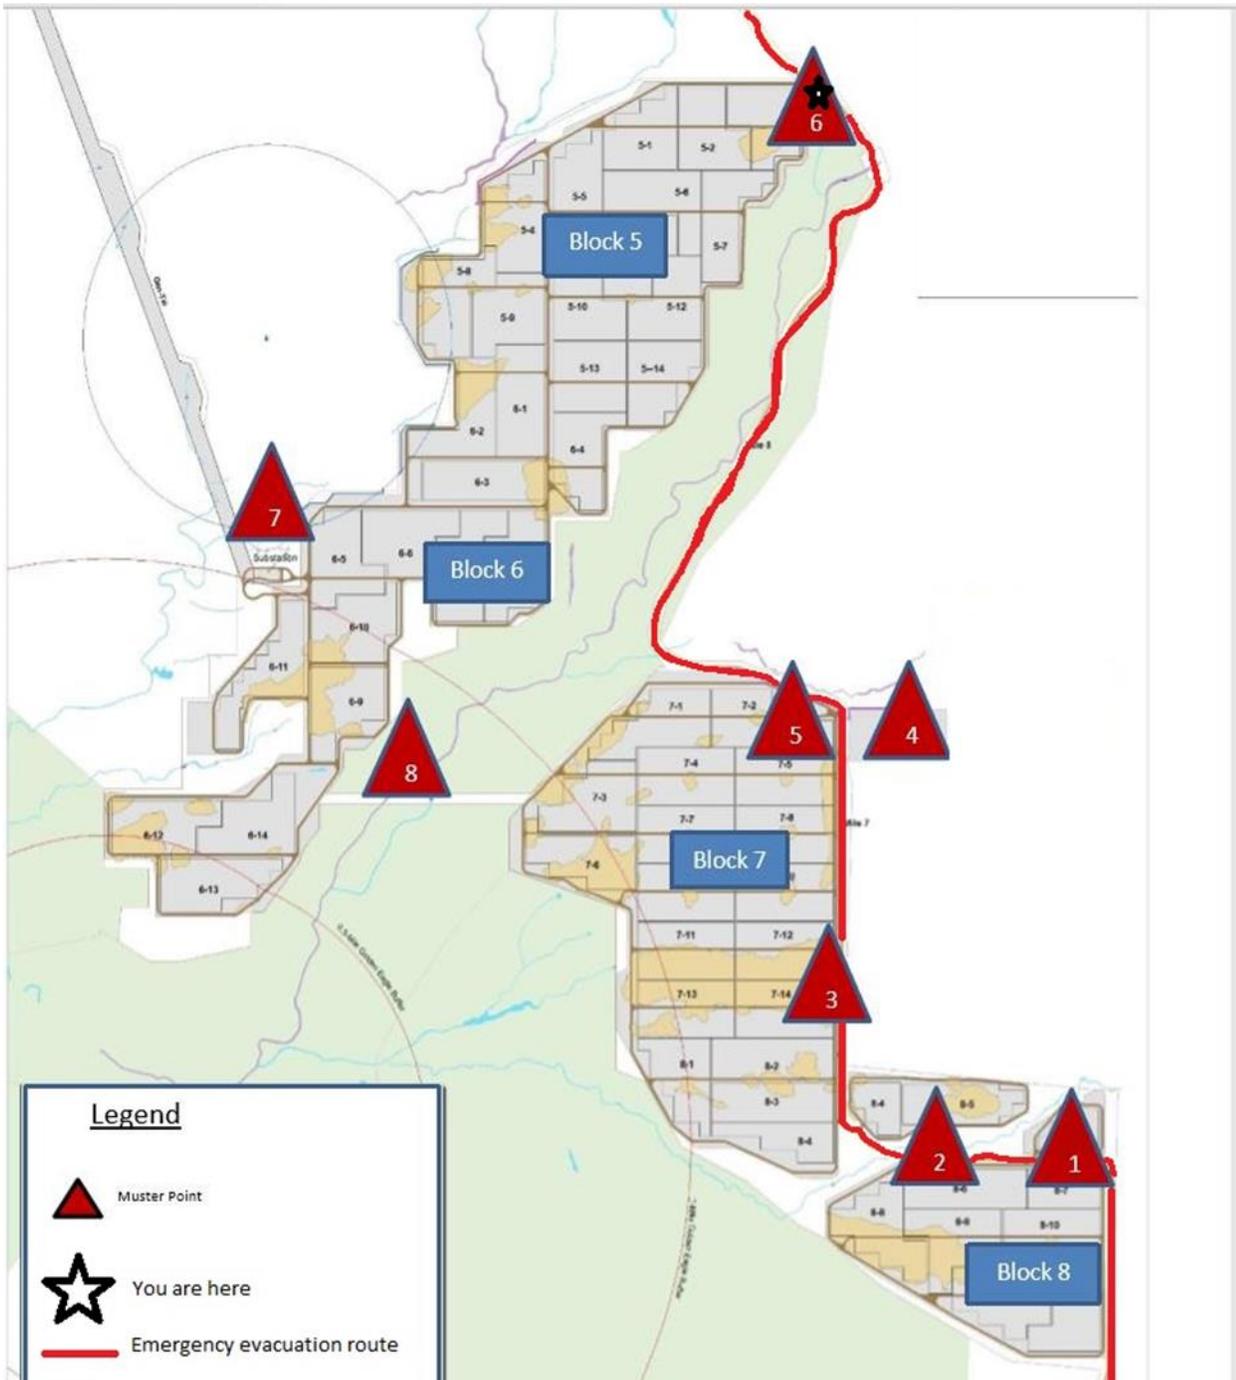
The Plant is a 200.96 direct current (DC) megawatts (MW) power plant with an alternating current (AC) power output of 150 MW. The Plant is set up on four blocks, namely Blocks: Five, Six, Seven, and Eight. These blocks comprise solar modules in arrays or rows, which sum up to 505,500 modules. These break down to approximately six per string or 30 per row. The modules are rated at 1500 volts of DC (VDC). The six modules on the strings are connected in parallel with an actual voltage output of 1000 VDC accounting for losses. The power output from these strings is fed into combiner boxes. The Plant is configured to have 50 strings per combiner box, making the total harness combiner boxes in the Plant 1,685. In addition, the Plant has 54 inverters and 54 medium voltage (MV) transformers. The output from the combiner boxes is fed to the inverters, which converts the 1000 VDC to a 600 VAC, then onto the MV transformer, which steps up the 600 V to 34.5 kV, where it is collected and sent to the substation. Please see Figure 1 for the layout of the CA Flats.

Figure 1: Showing the layout of the solar Plant

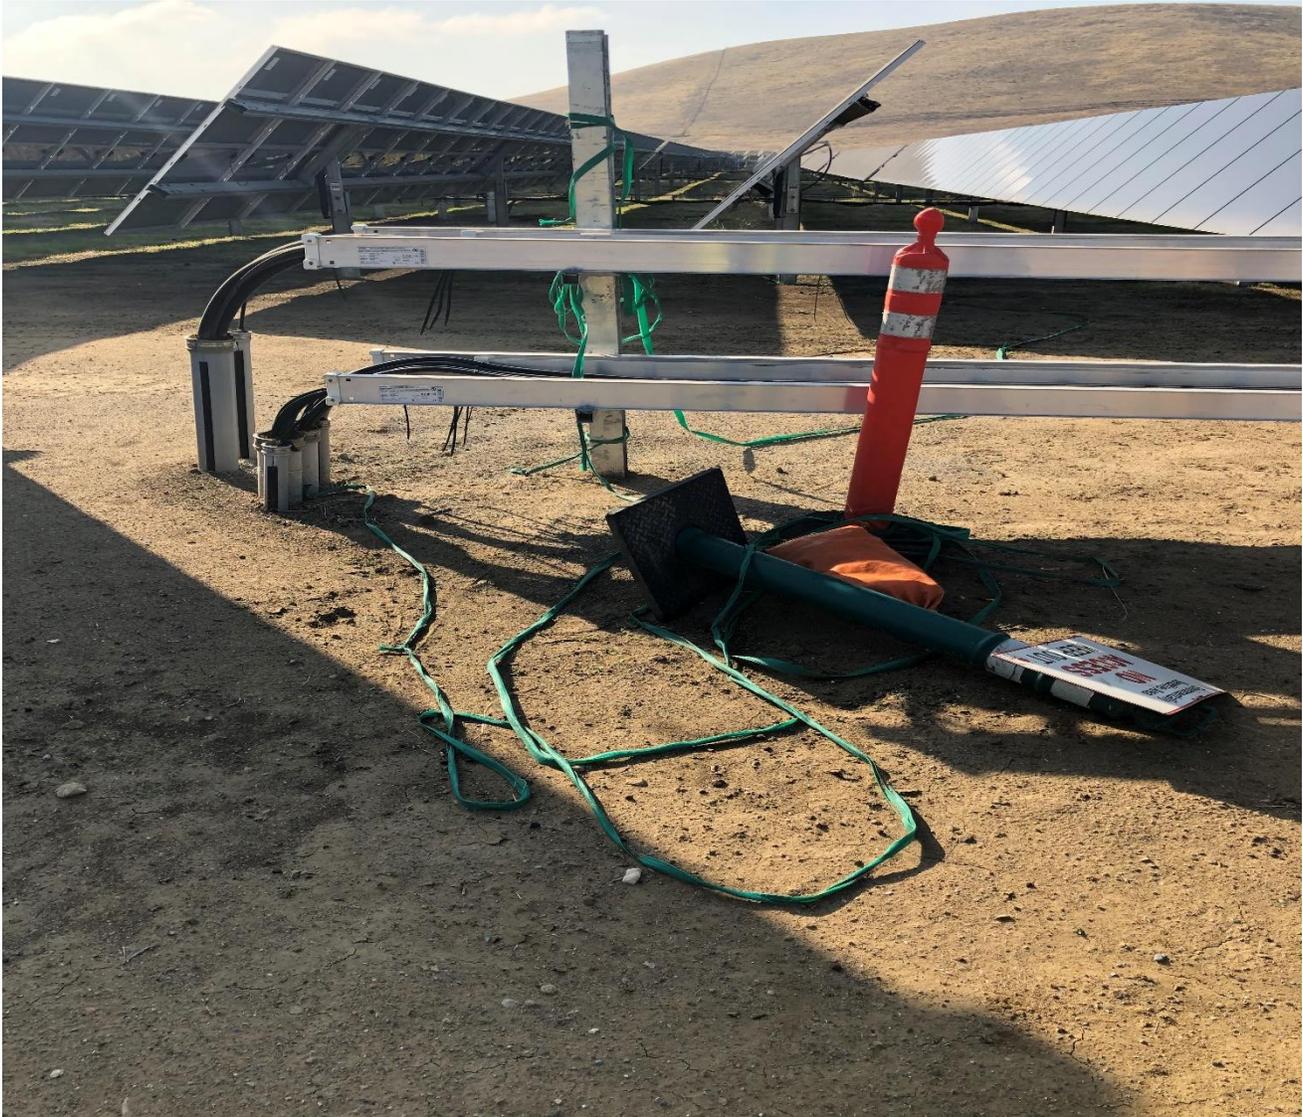
- The Plant has systematic issues in removing materials used for buffer zones for ecological purposes, posing a tripping hazard around the solar rows.
- There were tripping hazards that included construction materials left lying around walkways and the general area of the array sites.
- Improper storage in the server room, the warehouse, and the electric room in the substation.
- ESRB also noticed that the Tracker Control Cabinet latches were left unsecured.

Figure 2: Showing an array site with ecological buffers and construction materials

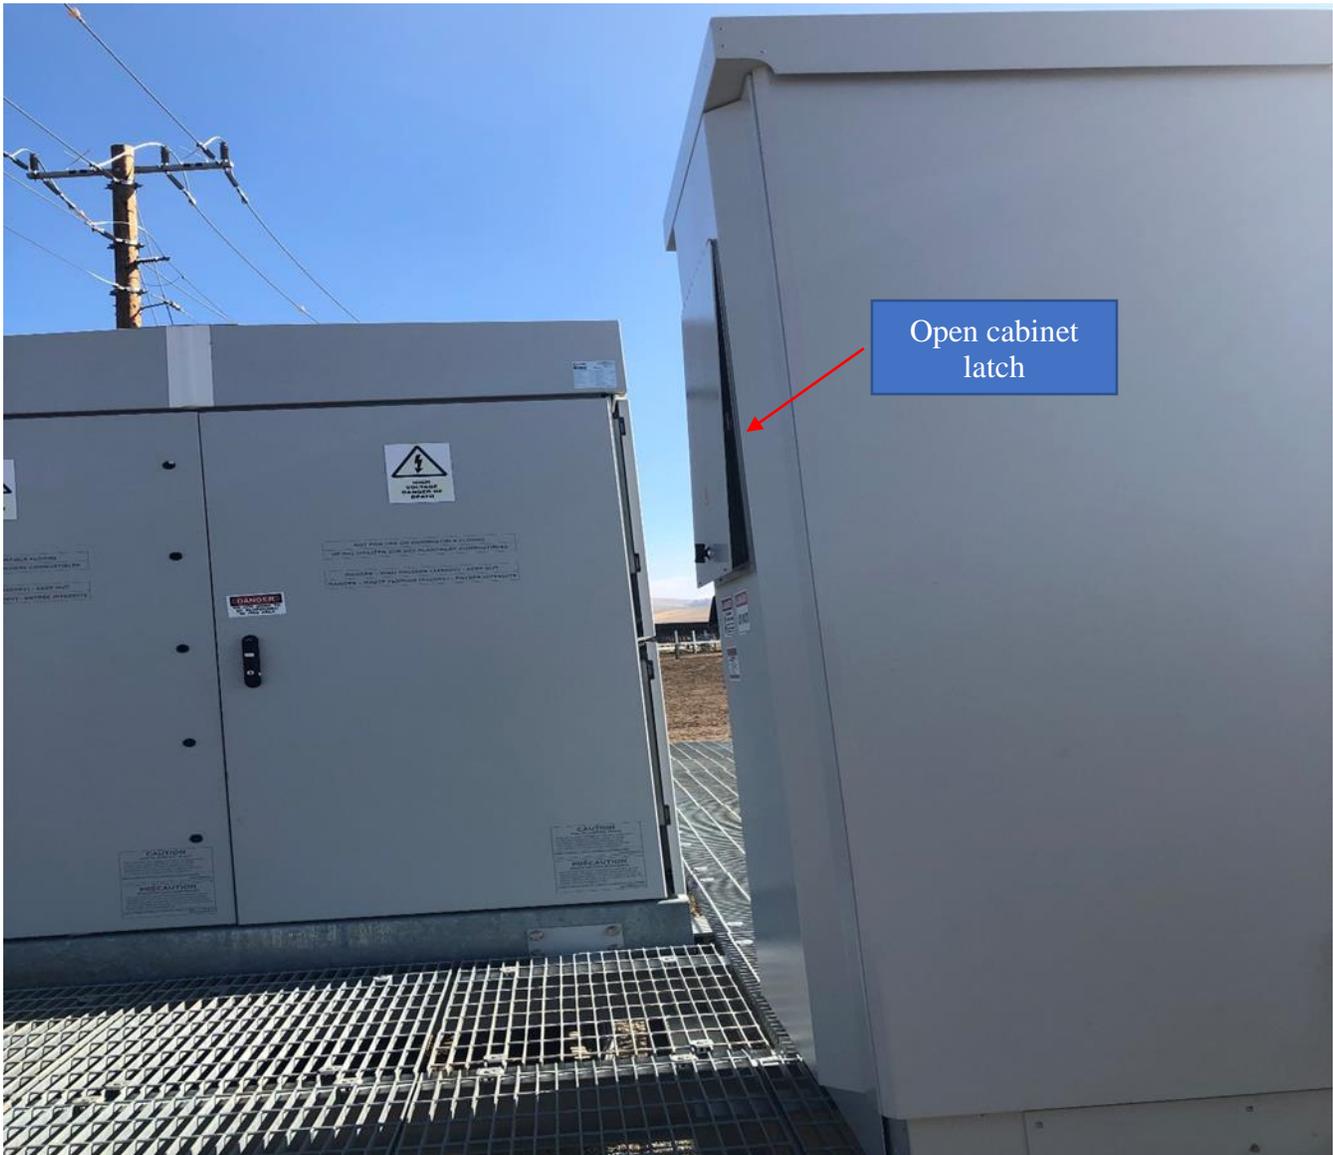
Figure 3: Showing an open latch at one of the Tracker Control Cabinets

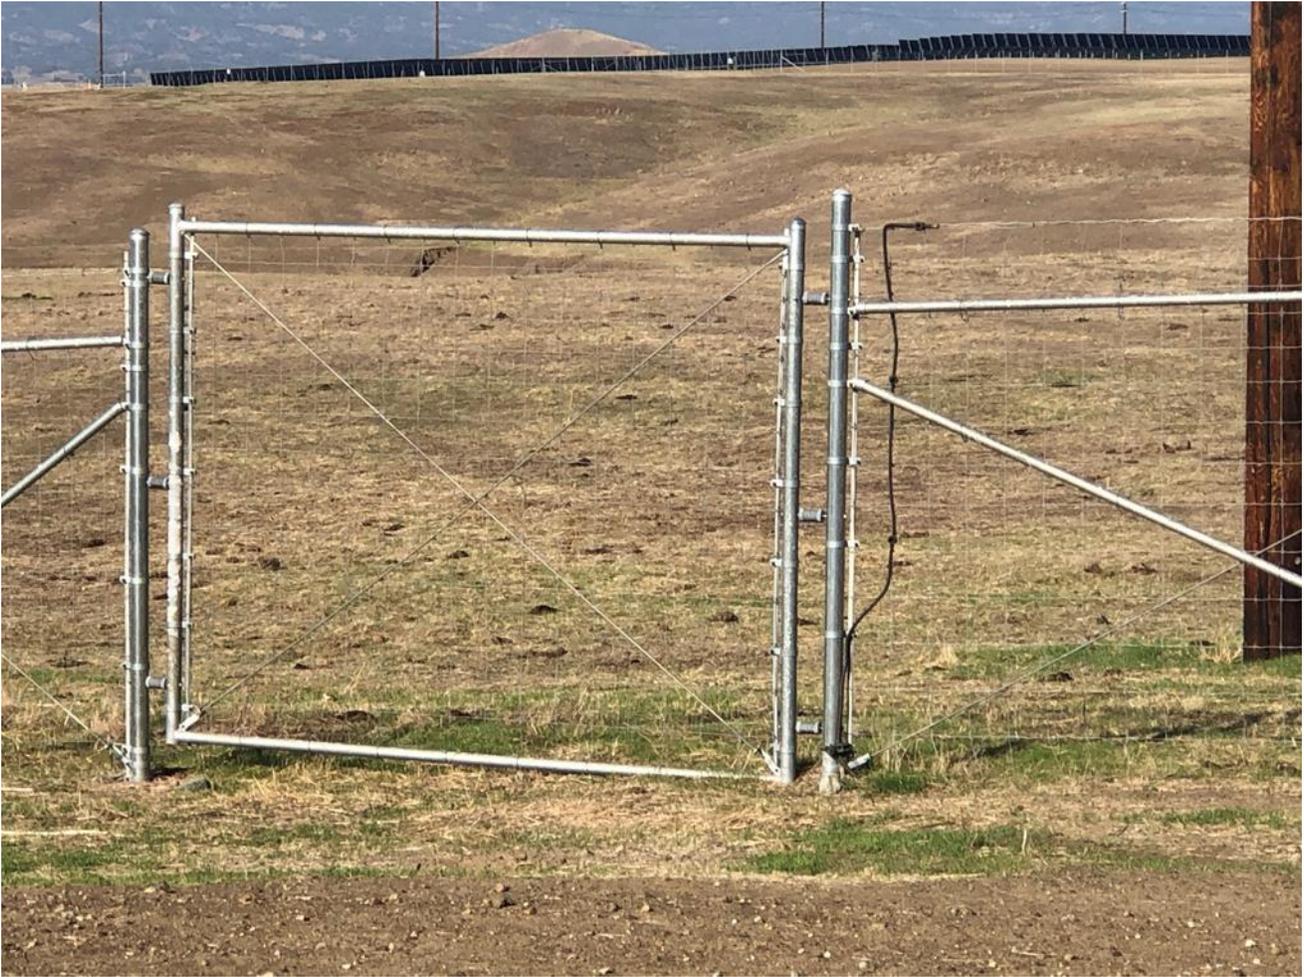
ESRB observed that many High Voltage (HV)/Danger signs on the fences, inverters, and field transformers are missing, illegible, or faded. Due to the size of the Plant and the limited number of NovaSource employees on-site, safety warning signs are vital to alert the public of the danger of high voltage facilities such as solar panels, combiner boxes, trackers, inverters, field transformers, cables, and overhead transmission lines. Therefore, the Plant must replace all illegible HV/Danger signs with legible signs and post proper signage at locations where they are missing.

Figure 4: Showing a section of the fence at a Block site without any signage

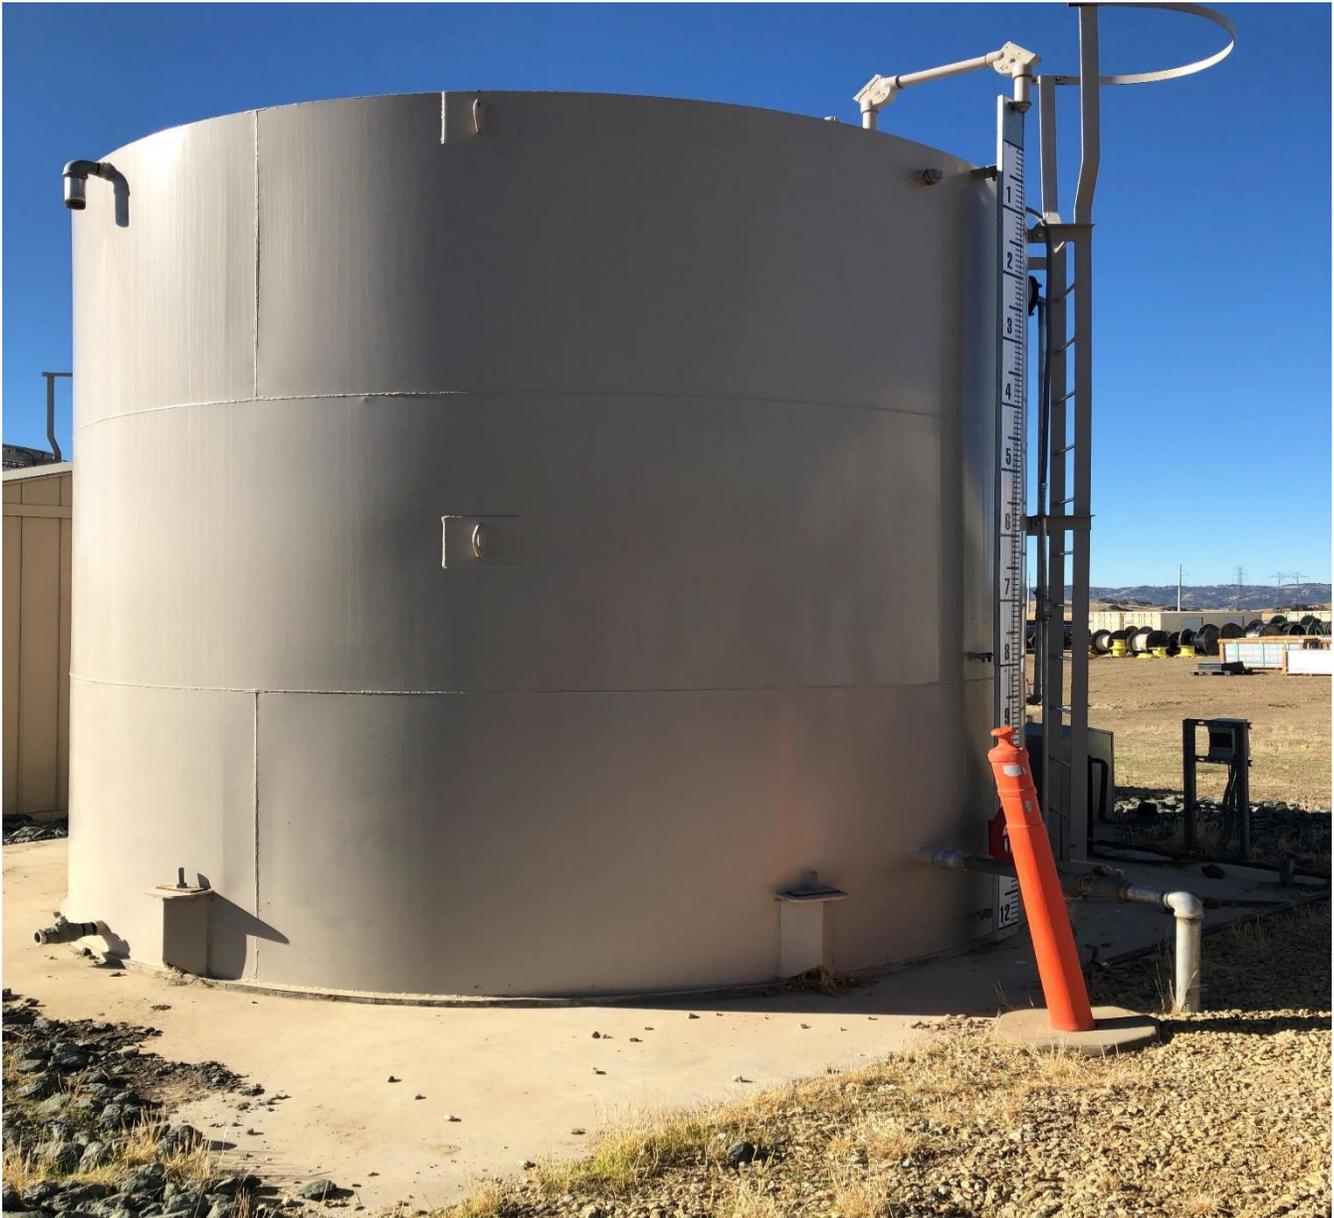
ESRB observed that the water tank at the CA Flats does not have a “Confined Space” warning sign on the exterior wall. This is a safety concern, and CA Flats must install at least one “Confined Space” warning sign at the outer wall of the water tank. In addition, the sign should be mounted on a visible side of the water tank.

Figure 5: Showing a water storage tank without any confinement warning sign

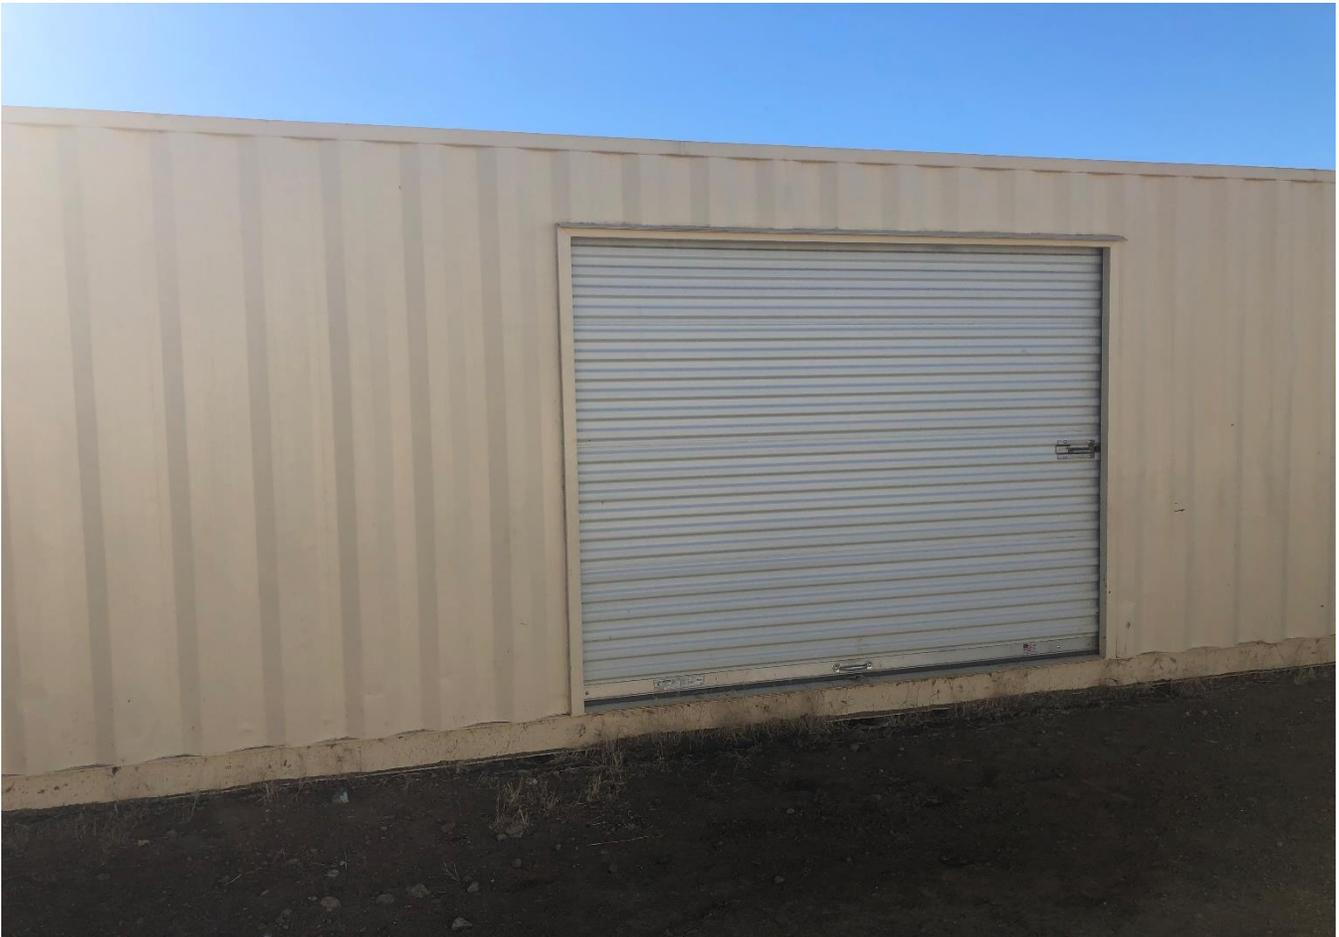
CA Flats uses various hazardous materials as part of its regular operation including gasoline, and battery electrolytes. However, ESRB observed that there was no Hazardous Materials (HAZMAT) warning sign:

Figure 6: Showing the entrance into the inflammable storage building

The NFPA establishes industry consensus standards for fire protection. NFPA 704¹ is the standard system for identifying hazardous materials for an emergency. Posting an NFPA placard is a standard industry practice to alert first responders, plant employees, and the public of the risks posed by a facility’s hazardous materials. This helps emergency workers determine what safety precautions and equipment to use and how best to respond to different scenarios. For example, CA Flats must install HAZMAT warning signs on its inflammable storage building entrance.

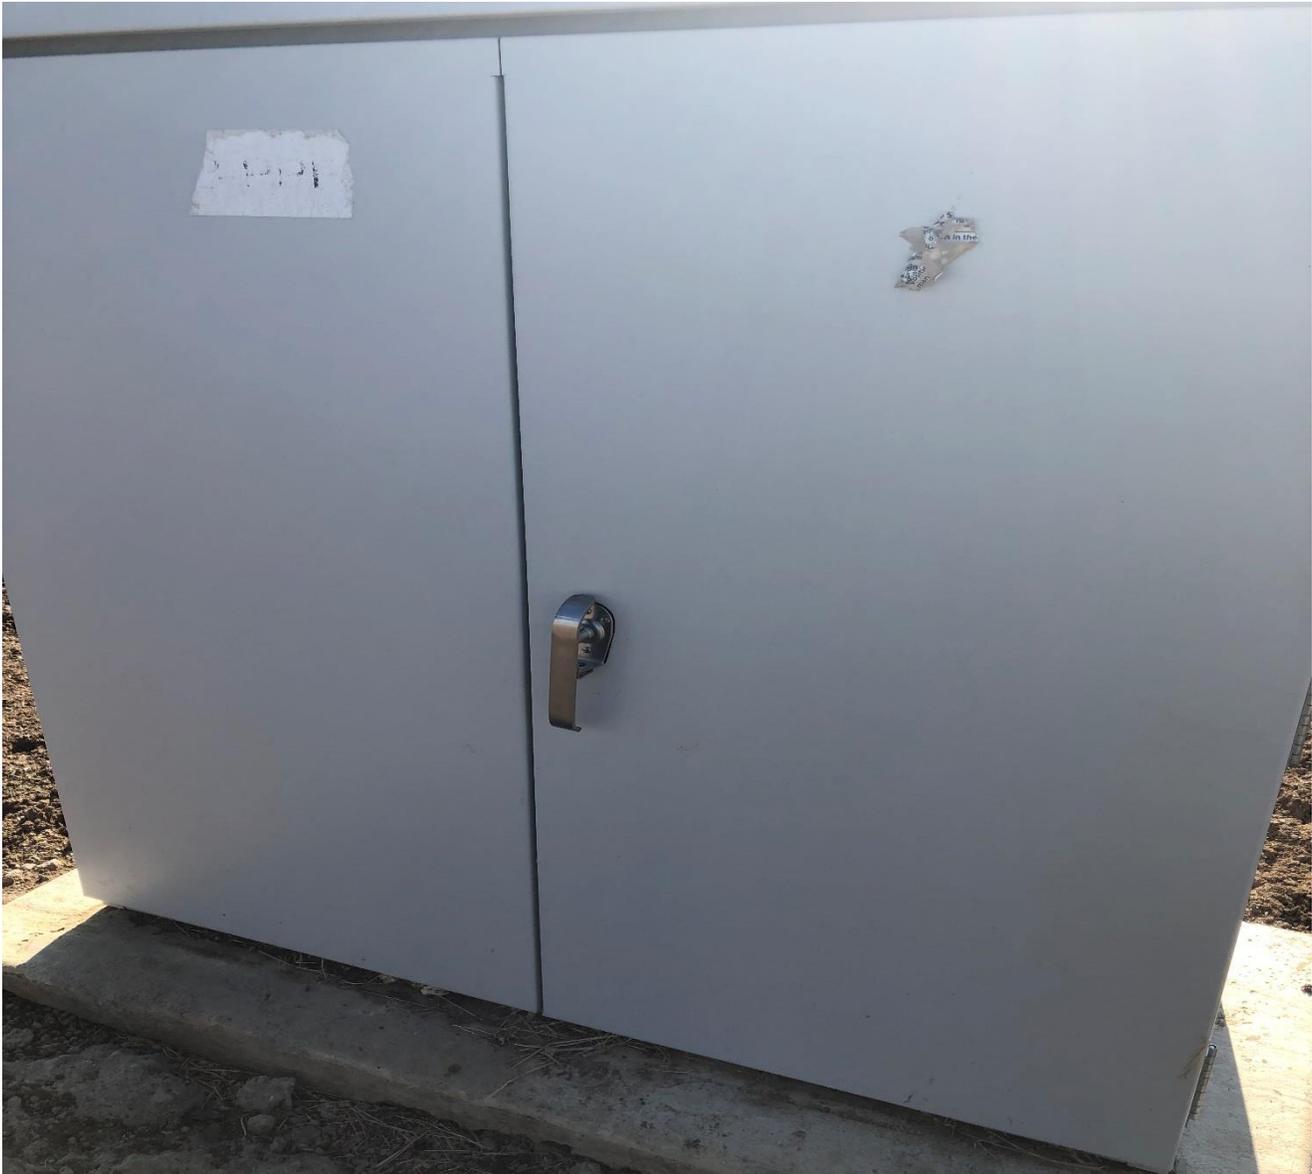
Many fiber optic pull cabinets and PVCs on the plant site have faded or peeled-off labels.

Figure 7: Showing a fiber pull cabinet with peeled-off equipment label

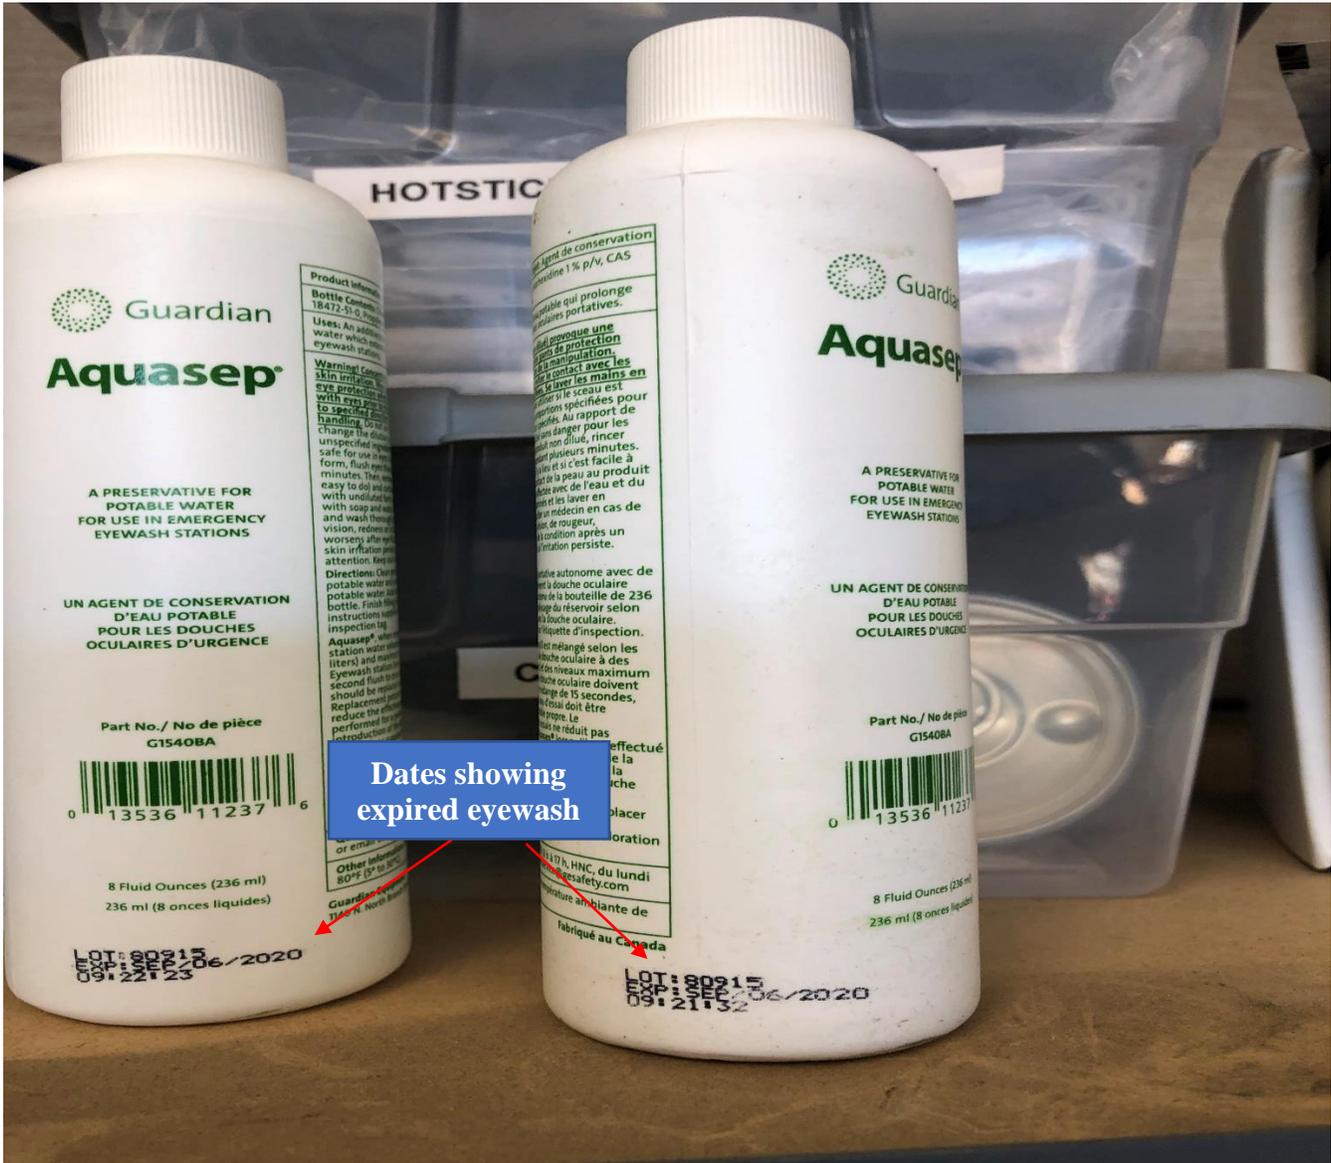
ESRB found expired chemicals such as eyewash in the Plant’s warehouse. Therefore, the Plant must establish an SLA Program that includes spare parts and other materials and chemicals. This should consist of when parts are obtained, manufactured, and their expected shelf life. Additionally, the SLA should include the items’ location and a scheme for disposal or recycling.

Figure 8: Showing expired eyewashes located in the warehouse

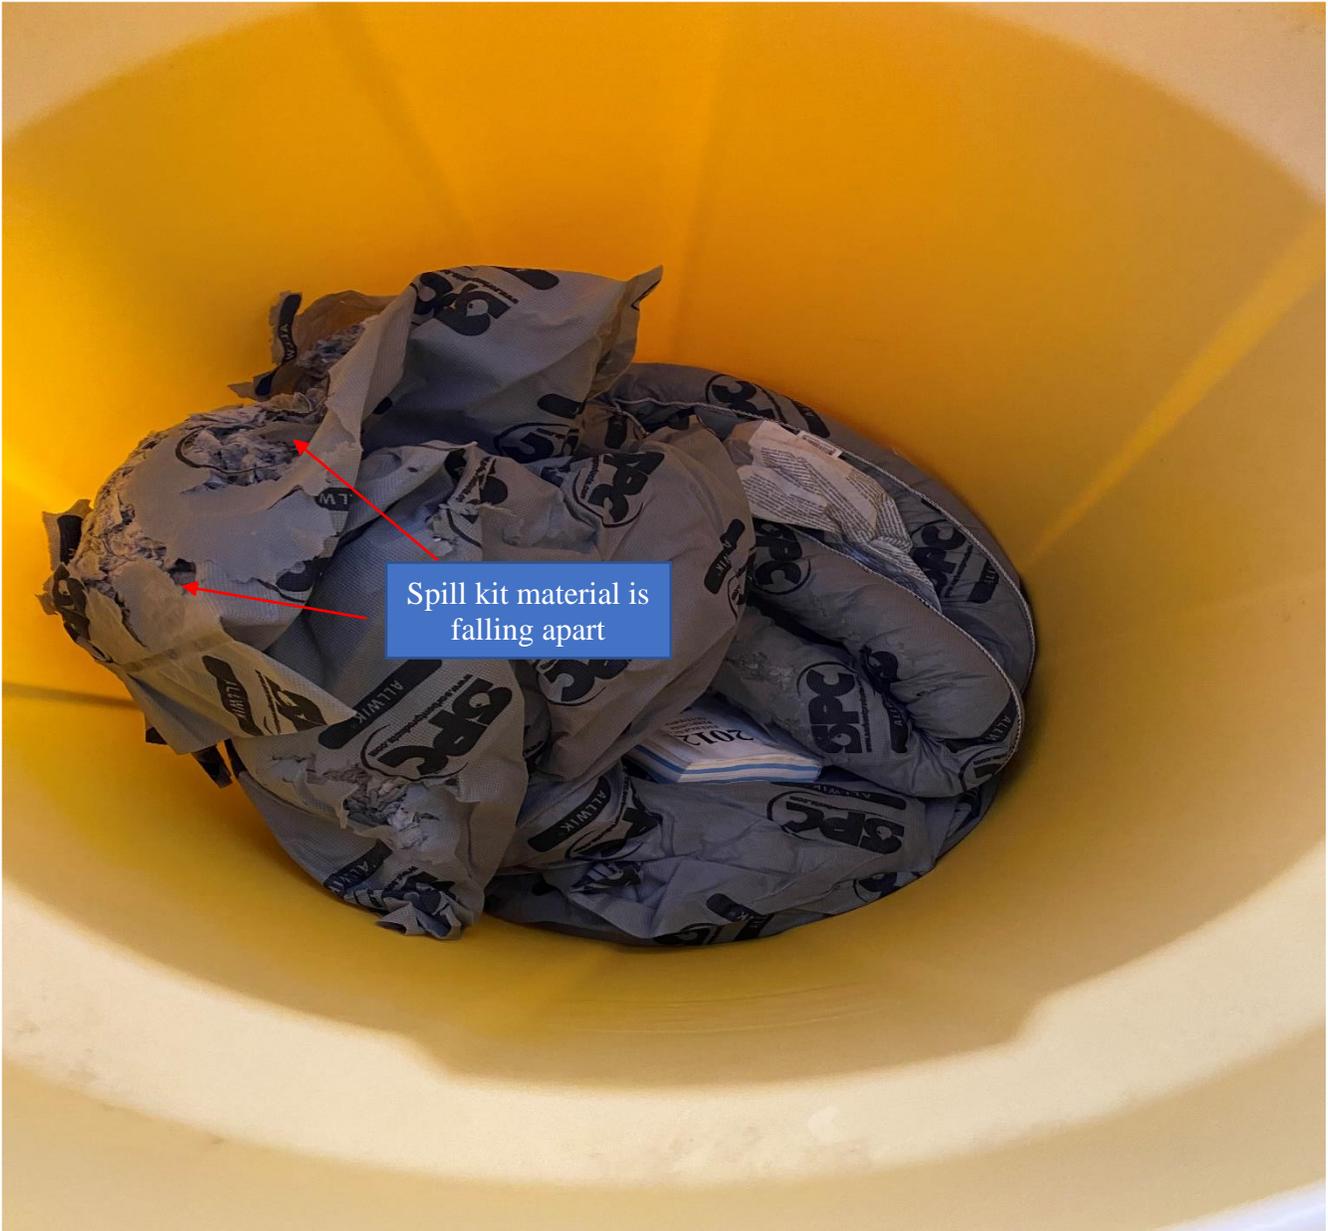
ESRB observed that the absorbent material in the Spill Kit is all degraded and falling apart, making them unusable when needed.

Figure 9: Degraded spill kit material in its storage location

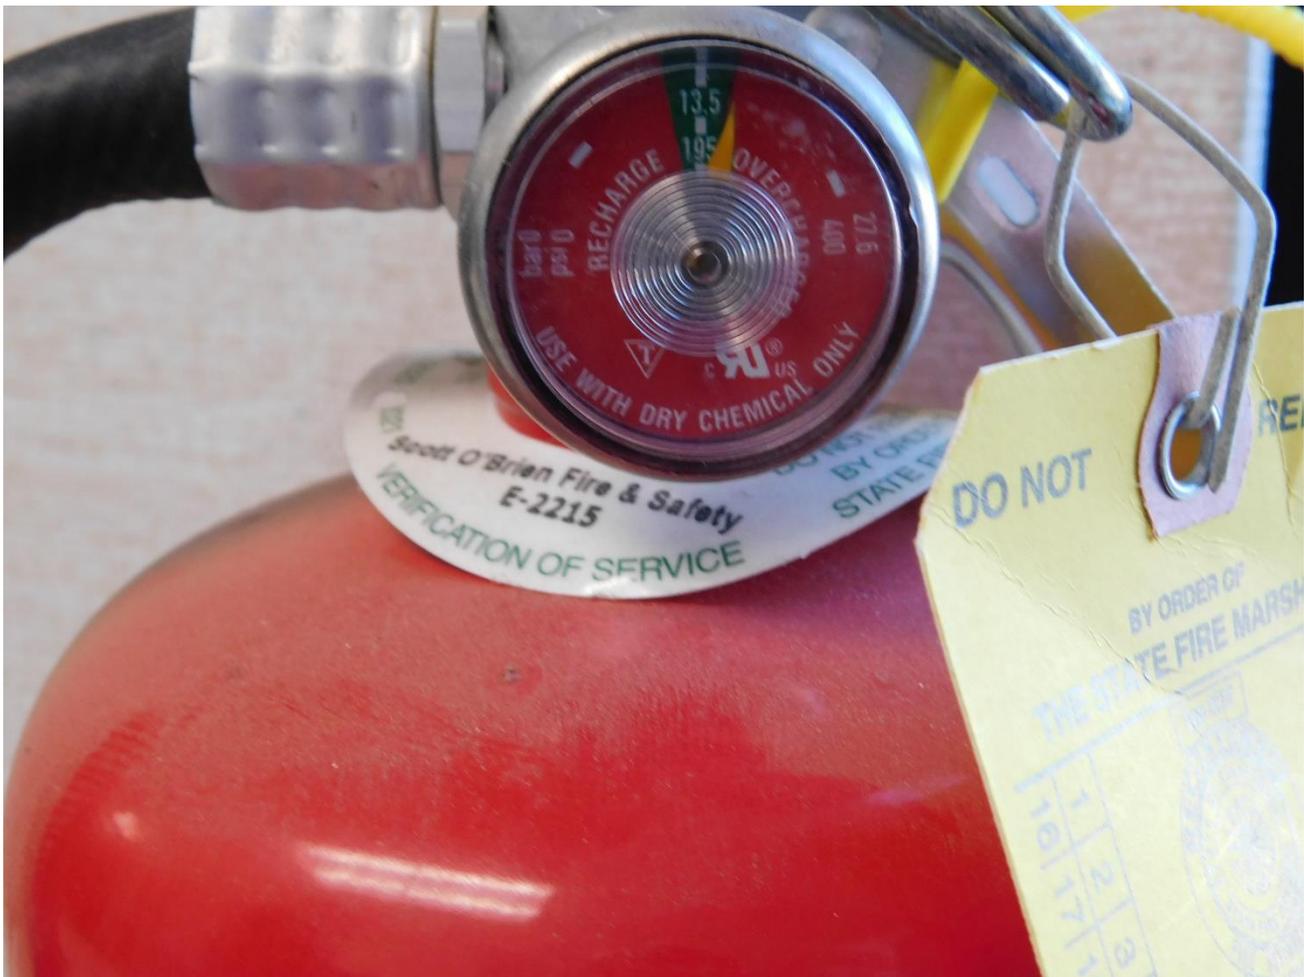
ESRB observed a fire extinguisher outside its designated pressure range by the office entrance.

Figure 10: Over-pressurized fire extinguisher

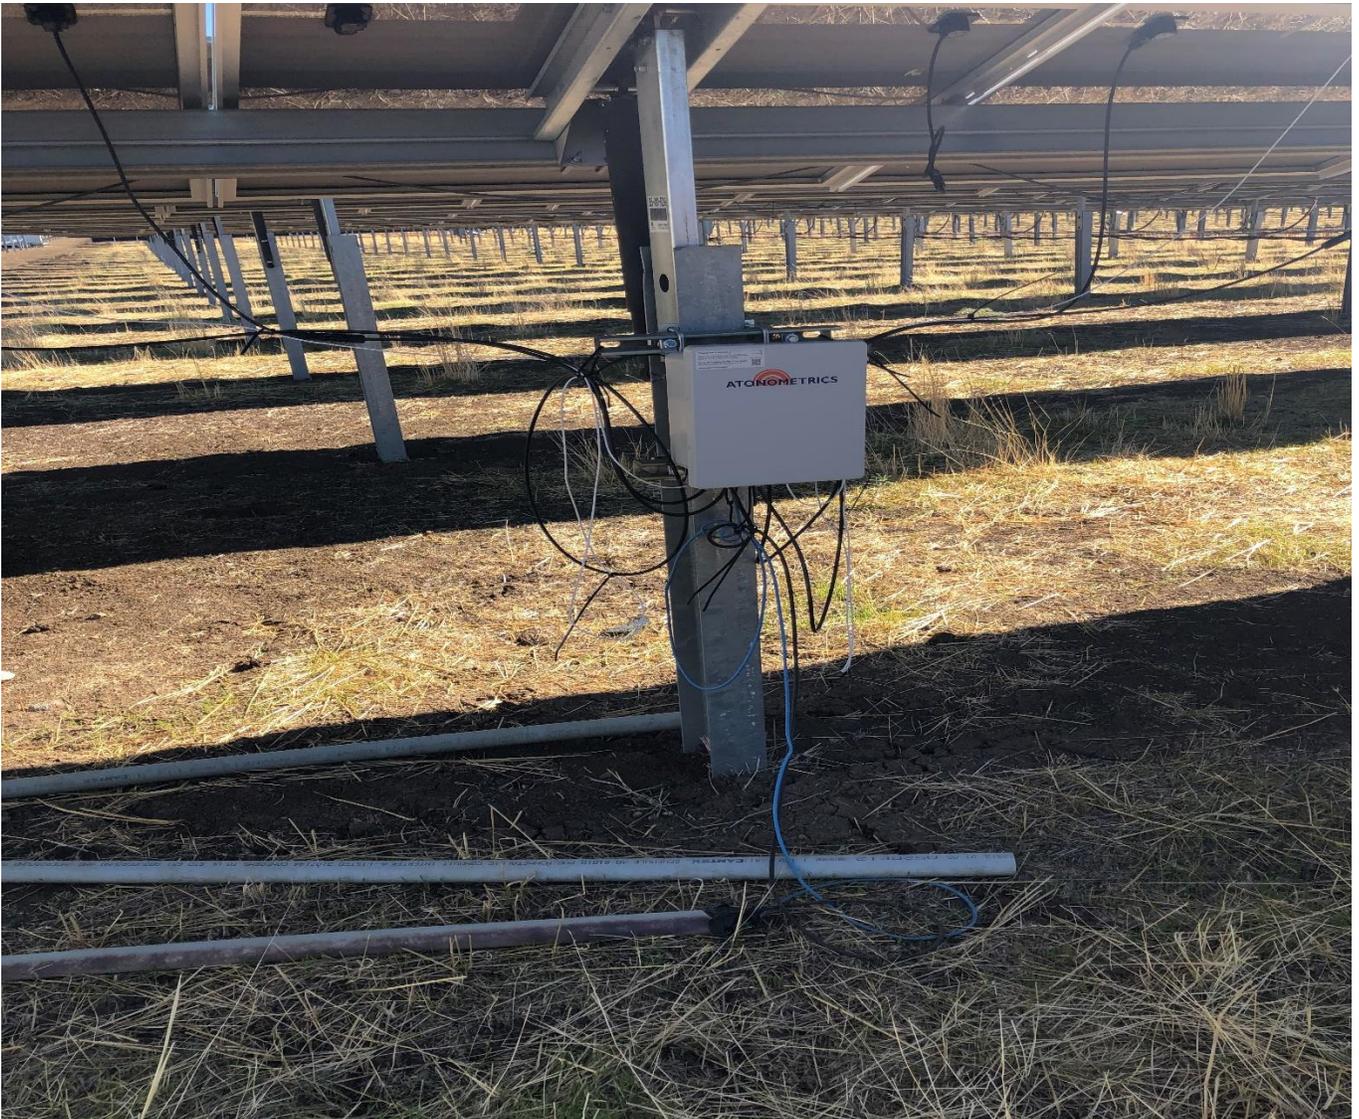
ESRB observed instances at the array sites where conductors were left unsecured and lying on the ground. This constitutes tripping hazard because they are electrical conductors that can be hazardous to the Plant employees; therefore, they should be properly secured to ensure safety and prevent service interruptions.

Figure 12: Showing conductors at a row in the solar array at the Plant

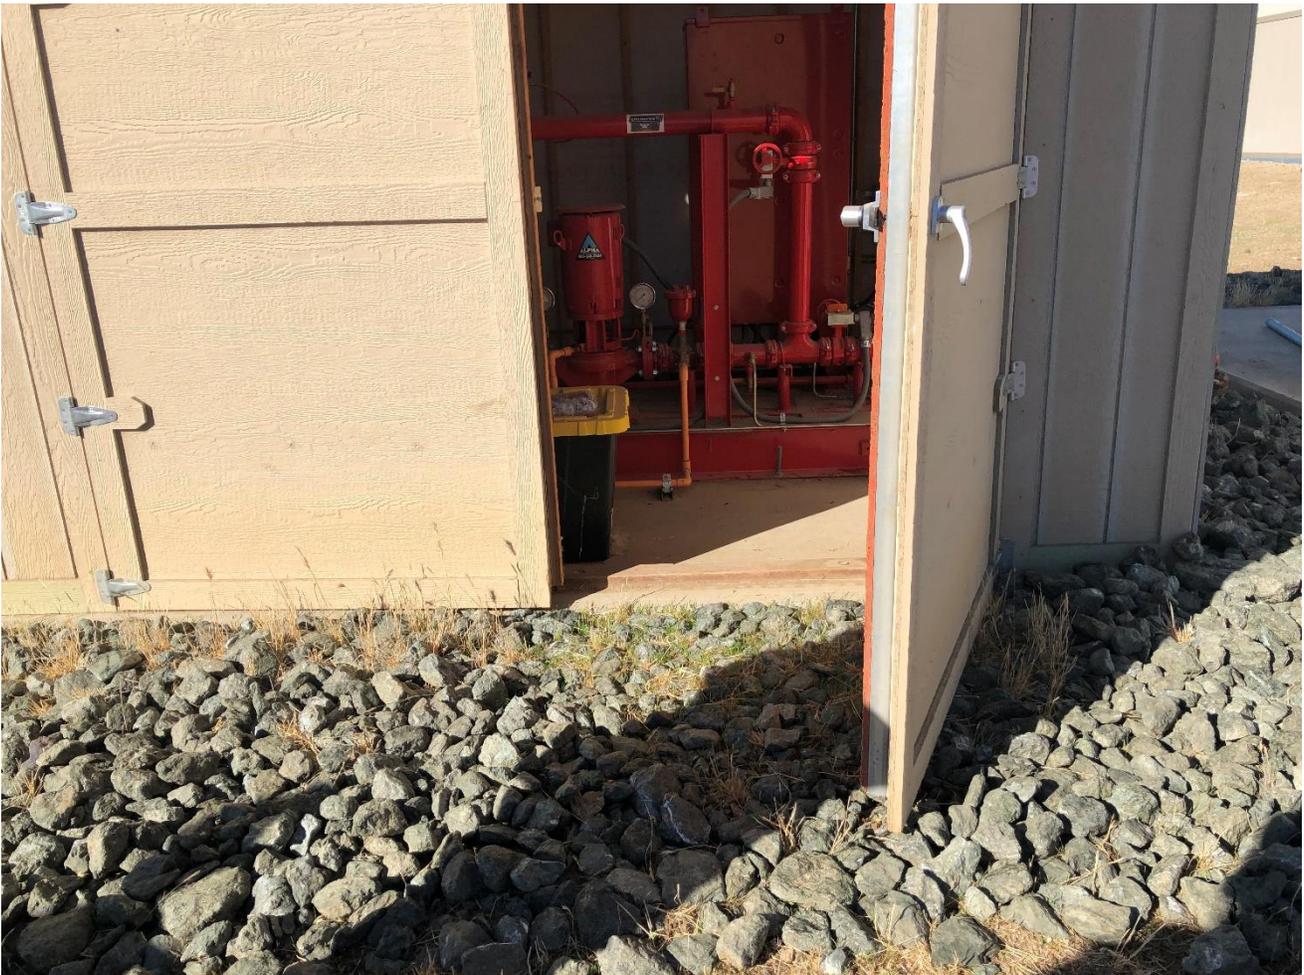
Figure 13: Showing the Plant’s fire pump house

The Plant should remove the rock obstruction hindering the opening of the doors of the fire pump house, which could cause a delay and problematic accessibility in the event of a fire emergency.
